**2758 Example Avenue  
St. Louis MO**

**Client(s): Example  
Inspection Date: 7/2/2018**

**Inspector: BPG Inspector #IL 450.000775 (IL), (MO)**

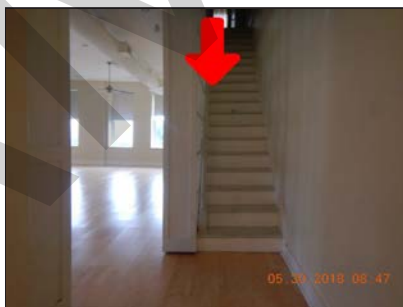
- ☒ ◆ The stairs to 3rd floor are leaning outward some which is common for this age. Be careful moving heavy furniture up these steps. Have a contractor provide supports under the steps to strengthen them.

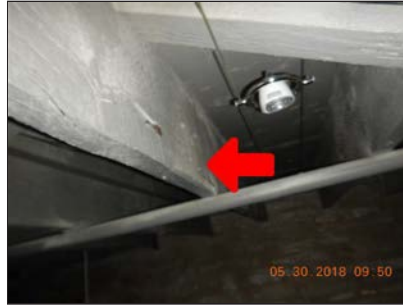
- ☒ ◆
  1. In basement, about center of area over the work tables, sister the deteriorated floor joist to ensure its strength. ~\$300
  2. There is another floor joist near by same area, that is cracked, sister it. ~\$150

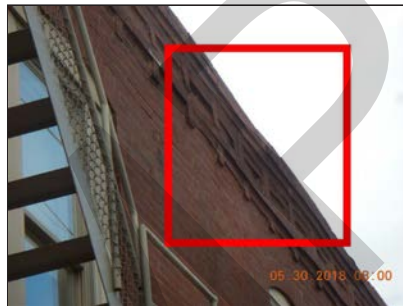
- ◆ The top of the west wall of front building is wavy from age. Keep the area well tuckpointed or conditions will get worse.

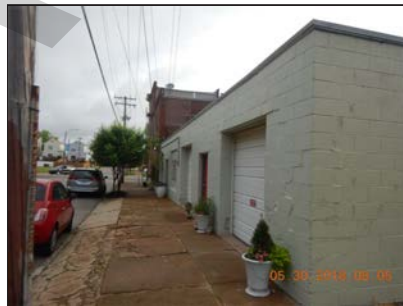
- ◆ The block west walls of rear of building have some stairstep cracks and other signs of movement. This mostly cracking off tops of windows/doors which is common. Keep all areas well sealed.
- 📍 ◆ The SW corner of the rear building appears to have been hit by a car/truck at some point in past. The blocks are cracked/damaged and somewhat displaced. Rebuilding the corner is not required in my opinion but, monitor/seal and maintain the area as necessary.

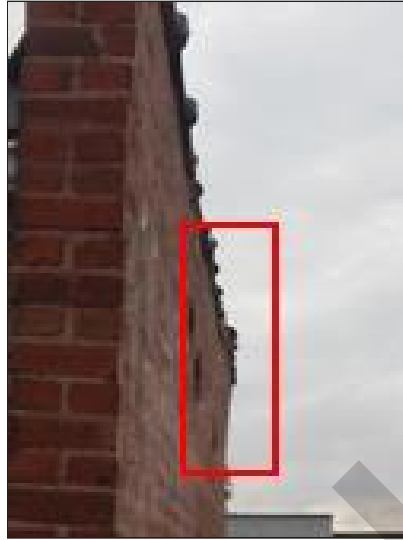
- ❌ ◆ At the NE corner of the front building, at the top corner, the wall is leaning outward. There is a star at this area but the wall is bulging around the star somewhat. Have a qualified contractor review this area at this time and rebuild or tie the wall back to existing framing. The wall needs stabilization to ensure long term service. ~\$1000 - \$2000 if the wall can be tied back to framing. ~\$7500 + to rebuild this corner area.

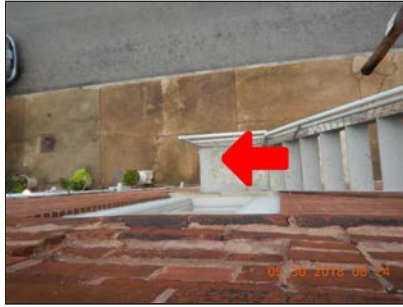
◆ The landing on the fire escape has no railing at the end and is unsafe. Have a railing installed. ~\$400 - \$800

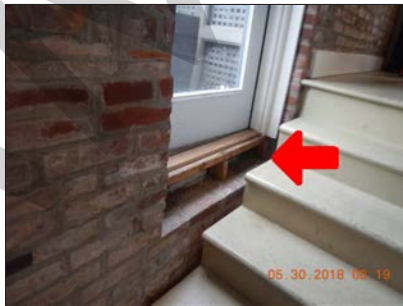
◆ Finish the open conditions at the door out to rooftop deck. Repair interior and exterior areas of the deck.

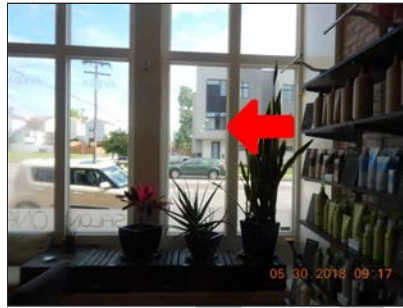
- ☒ ◆
  1. At front of first floor, replace the third window from the west that is fogged from a broken thermal seal.
  2. Also the 2nd from east window has a broken thermal seal and needs replacement.
  3. ~\$750 - \$1500 for each window.

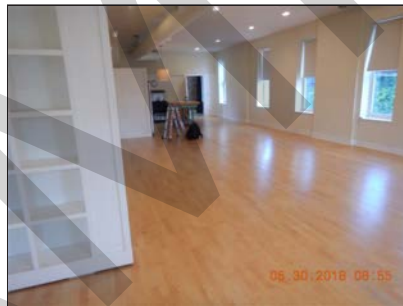
- ☒ ◆ The wood windows at 3rd and 2nd floors: top sashes slide down when unlocked or lower sash is raised, windows are hard/stiff to open/close and overall are weak from age. Have a contractor review each window on 3rd and 2nd floor and service and repair to ensure they operate easily, safely and properly. ~\$75 a window on average. About 15 windows.

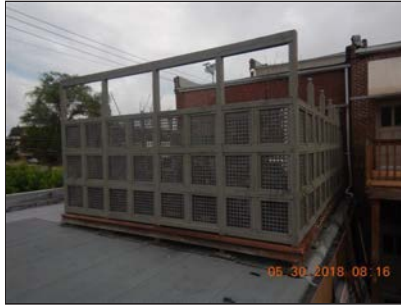
- ☒ ◆ The walls around the rooftop deck are leaning and wavy and deteriorated and a strong wind might blow them over. Repair/replace these walls as needed. \$750 - \$1500 to repair. Cost depends on how thorough you want to be.

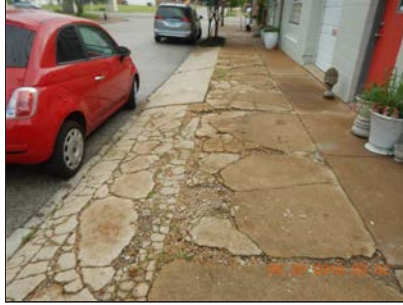
- ☒ ◆ City sidewalk along west side of building is very cracked and deteriorated. Replacement of the concrete seems like the best solution. Inquire if you or the city is responsible. Not estimated due to unknowns.

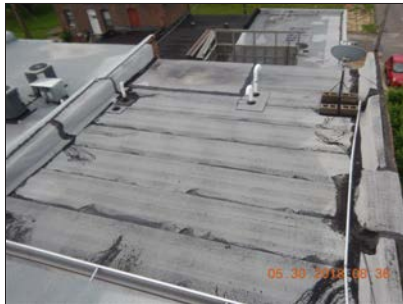
- ✘ ◆ The roofing over the mid section of the building is deteriorated, about 15 + years old, losing aggregate, has various gaps, is ponding water along the gutter area, no termination bars at edges and rear gutter area and has been sealed with tar at seams. We recommend replacement of this roof section at this time. If not replaced now, the roof possibly has 1 - 2 years of service remaining with possibility of leaks. This section is about 790 square feet. ~\$3000 - \$6000 to replace.

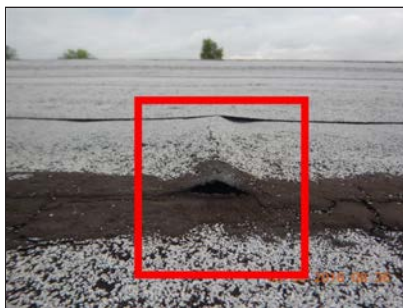
- ❌ ◆ The roofing over the third floor is old and deteriorated, has missing aggregate, sealed seams, uphill seams, no termination bars at edges at rear gutter, and needs replacement at this time. The area is about 790 square feet which, is about the same size as the mid-section roof. ~\$3000 - \$6000 to replace.

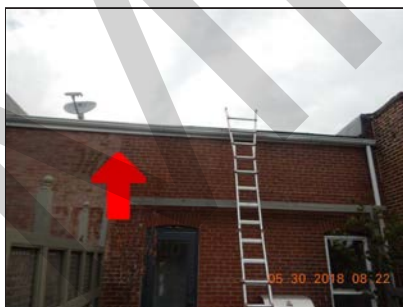
- ⚠️ ◆ Gutter along rear of mid-section roof is leaking at the seams - repair/seal.

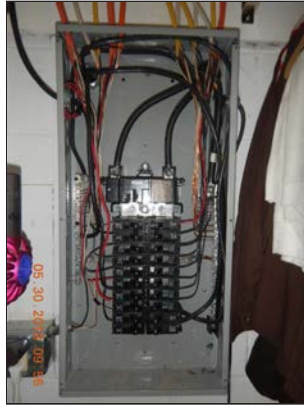
- ☒ ◆ The electric panel for the rear apartment is in a closet. There should be three feet of clear space in front of electric panels and panels should not be located in closets. Remove the storage from in front of the panel for safety reasons.

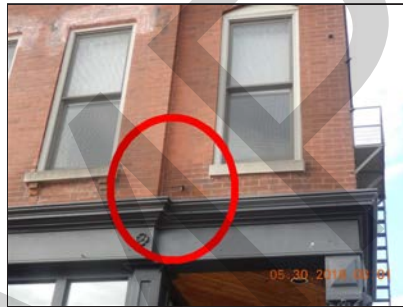
- ❌ ♦ Have an electrician remove the open/loose wiring at the front of the building over the entry way. ~\$150

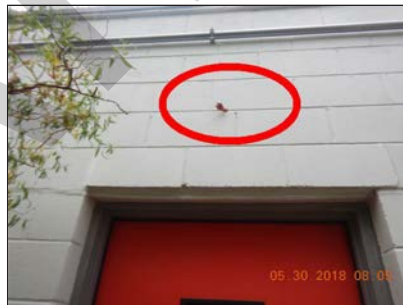
- ❌ ♦ Have electrician remove/enclose the open ended wiring over red door at west side of rear building. ~\$150

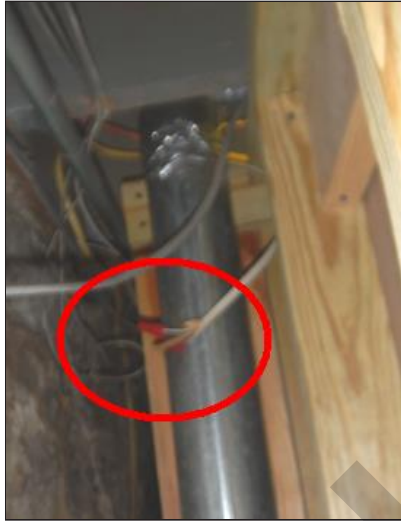
- ❌ ♦ Behind the wall at the basement laundry equipment - have electrician place the open wiring in a junction box. ~\$100

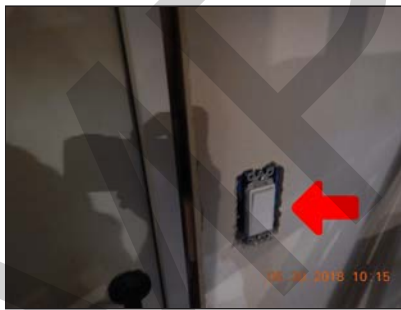
- 📷 ♦ Where needed install missing cover plates on switches and outlets and at junction boxes to contain splices properly.

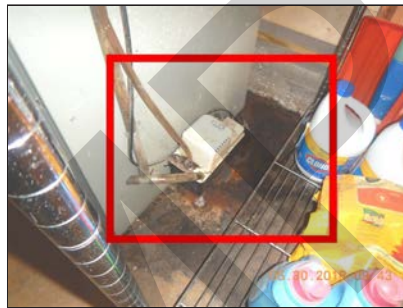
- ✗ ◆ At the basement furnace the condensate pump is leaking out water. Have it repair/replaced at this time. ~\$250 - \$500.

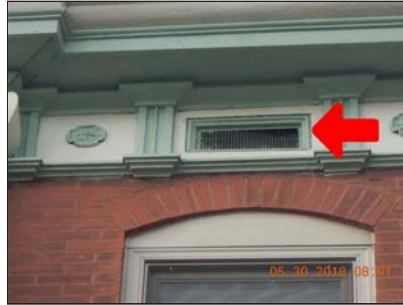
- 🔲 ◆ Repair the broken out attic vent screen at front NW upper corner of building. Needed to keep pests out of attic.

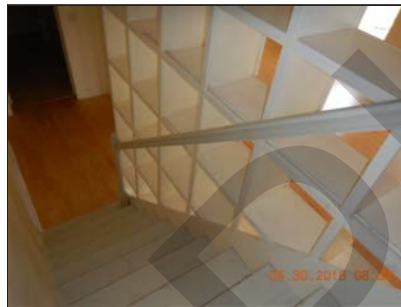
- ☒ ◆ Enclose the side of the steps to 3rd floor so there are no gaps greater than four inches.

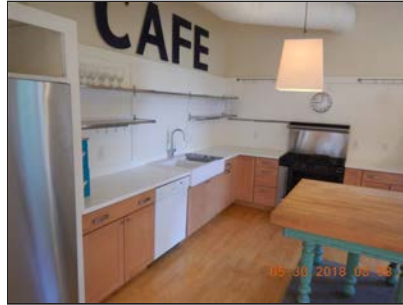
- ☒ ◆ Replace the plastic water supply line used at 2nd floor refrigerator with a copper water line. The plastic lines sometimes split open and leak.
- ◆ Kitchen appliances in both kitchens responded normally.
