Buyers Protection Group

**4 Maple Street USA**

**Client(s): Smith**  
**Inspection Date: 4/15/2015**

**Inspector: Timothy Clark #**

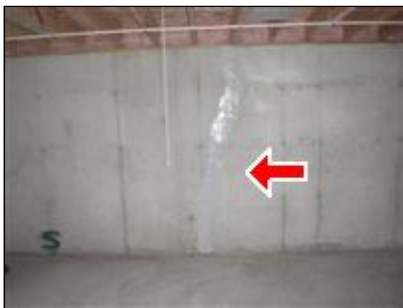
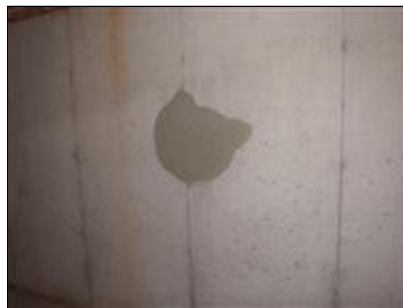
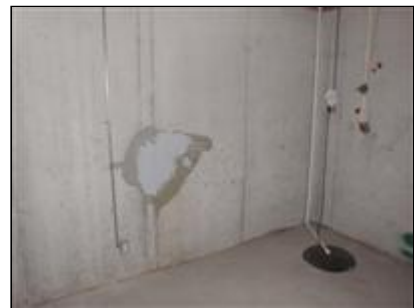
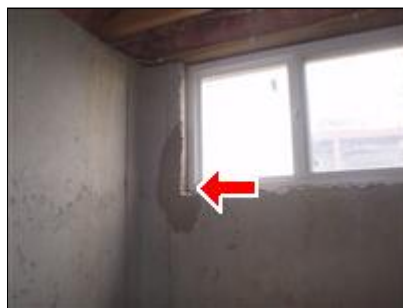
- ◆ Forecasting future performance is impossible because heavy rainfall, drought and other unpredictable soil conditions can produce foundation movement.
- ◆ The epoxy / urethane patching visible in the basement at front, side, and rear foundation wall(s) is a well-established procedure for structural bonding and leak control. Obtain any available warranties associated with this installation.

- 13. The epoxy / urethane patching visible in the basement at front, side, and rear foundation wall(s) is a well-established procedure for structural bonding and leak control. Obtain any available warranties associated with this installation.

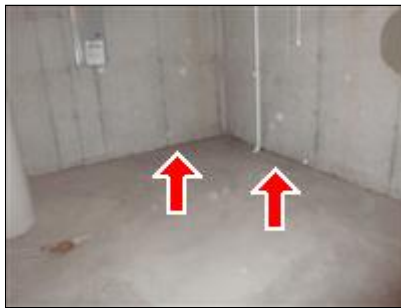
- ☒ ◆ There are some stains on the floor at the SE corner of the basement that might indicate some water seepage into this area. Monitor the conditions. Maintain exterior gutters and ground to slope away from the home.

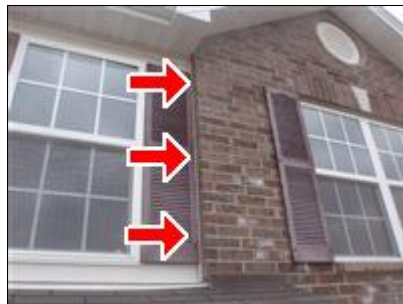
- 📍 ◆ Over the front porch, freshen the caulk where the brick meets the siding.

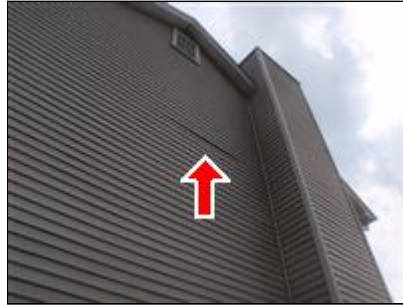
- ❌ ◆ Repair the siding that is loose at the west side of home.

- ☒ 1. Repair the siding that is loose at the west side of home.

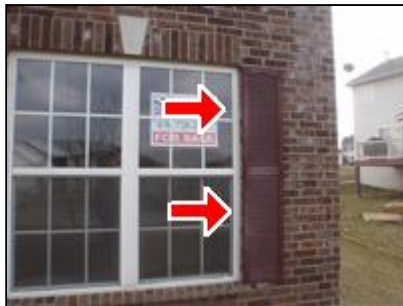
- ◆ Caulk and seal the gaps around the windows at the front of home. Seal where the brick meets the siding.

Example area, seal ALL gaped open areas around windows

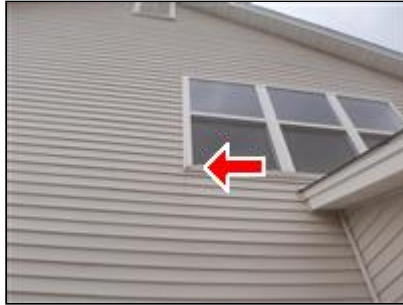
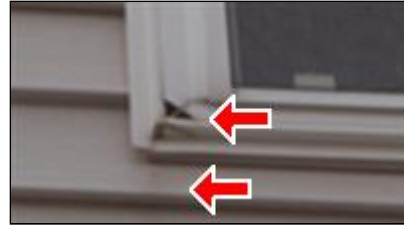
- ◆ At the east side of the home, at bottom corner of south master bedroom window, the bottom left corner of the window frame has a hole in it and there is a water streak on the siding below the hole. The hole appears to be a broken corner of the frame. Seal the area to ensure water can not enter into the wall. The current conditions in the wall are unknown.

- 19. At the east side of the home, at bottom corner of south master bedroom window, the bottom left corner of the window frame has a hole in it and there is a water streak on the siding below the hole. The hole appears to be a broken corner of the frame. Seal the area to ensure water can not enter into the wall. The current conditions in the wall are unknown.

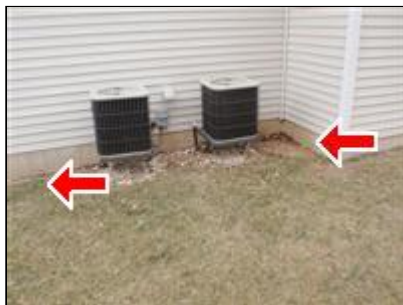
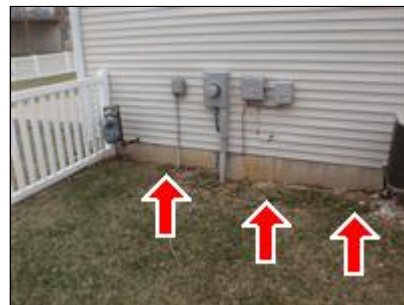
- ☒ ◆ The ground is low at area by the AC compressors and electric meter. Add dirt to area to slope the area away from the home. The ground is also low at areas around the rear patio, add dirt to the areas to slope away. Monitor other areas around the home and ensure there is a positive slope away

- 20. The ground is low at area by the AC compressors and electric meter. Add dirt to area to slope the area away from the home. The ground is also low at areas around the rear patio, add dirt to the areas to slope away. Monitor other areas around the home and ensure there is a positive slope away
- 21. The backyard slopes toward the home (SW corner). Ideally the yard would slope away. Monitor the yard and as possible improve the drainage to slope away from the home. Water accumulation at the exterior foundation will cause water to leak into the basement or foundation problems to develop.

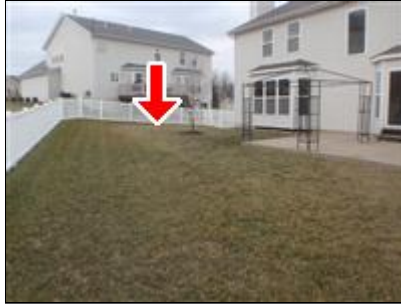
- ▣ ♦ The backyard slopes toward the home (SW corner). Ideally the yard would slope away. Monitor the yard and as possible improve the drainage to slope away from the home. Water accumulation at the exterior foundation will cause water to leak into the basement or foundation problems to develop.

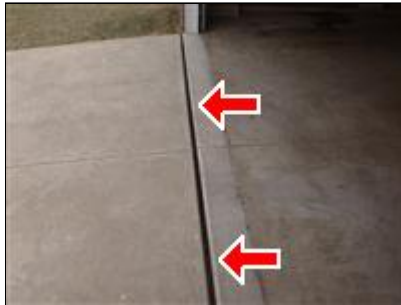
- ▣ ♦ Seal the open expansion joints in the driveway to help prevent water penetration below the concrete and possibly settlement.

Example, there are others too

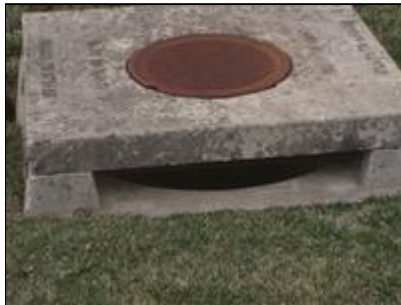
- ♦ Landscaping features are in generally good repair and the grounds tended typically for the area.
- ♦ The storm drain in the front yard has openings on the sides large enough for small children to fall through. Install protective grates or contact the Sewer District for correction.

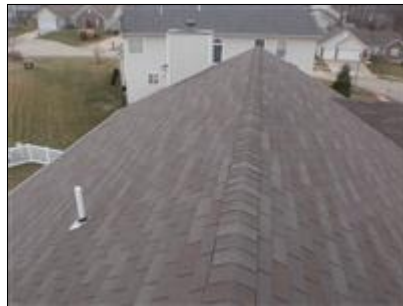
- 📷 ◆ There are some spots of tar on the east side shingles that are visible outside the master bedroom windows. Ideally these shingles would be replaced to ensure long term service.

- 23. There are some spots of tar on the east side shingles that are visible outside the master bedroom windows. Ideally these shingles would be replaced to ensure long term service.

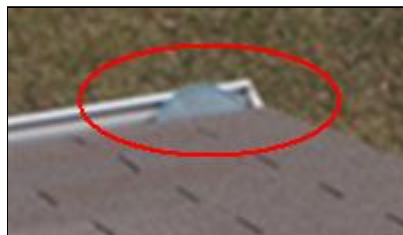
- ◆ The slope of the gutters was not evaluated, monitor and adjust as necessary.
- 📷 ◆ Remove the plastic lid in the gutter at rear slope at the SW corner to ensure the gutter can flow water properly.

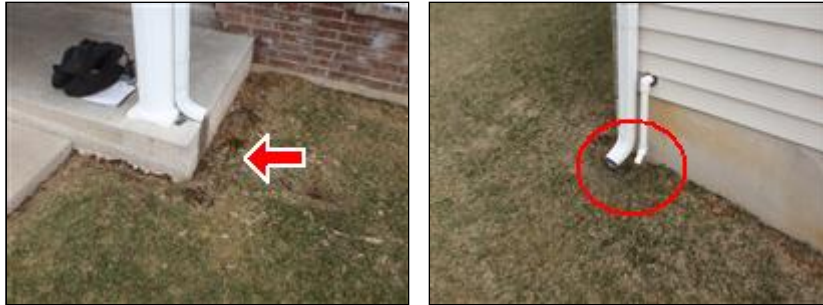
- Install downspouts where needed around the home. There is some soil erosion around the front corner of the front porch from lack of a splash block; add some dirt to the area.

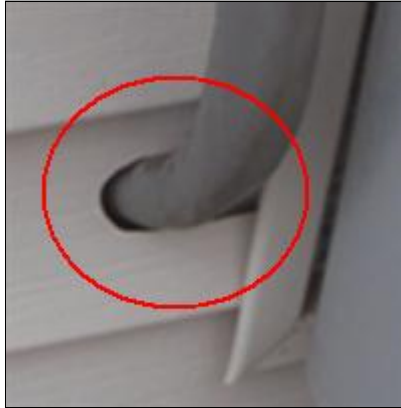
◆ At the exterior electric meter where the service wire enters the home through the siding, seal-up the area around the wire to prevent water from entering.

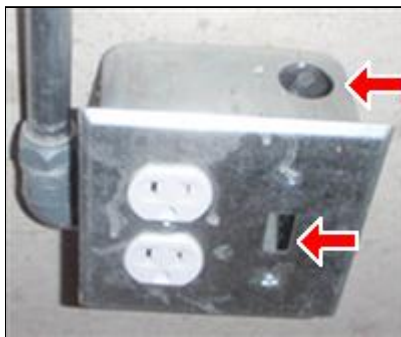
- ☒ ◆ Install a different junction box or seal-up the open knockouts in the junction box mounted on west basement wall.

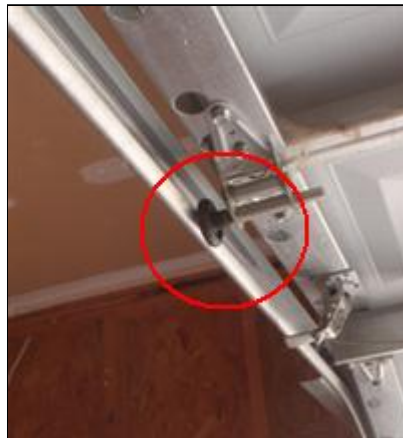
- ◆ The garage door equipment responded properly to the automatic opener. The downward pressure safety reverse was not tested. Check the safety reverses periodically to ensure they reverse properly.
- ❌ ◆ As facing the house, the right side garage door roller is out of track, repair/replace as the door can not be used until repaired.

- ☒ 7. As facing the house, the right side garage door roller is out of track, repair/replace as the door can not be used until repaired.

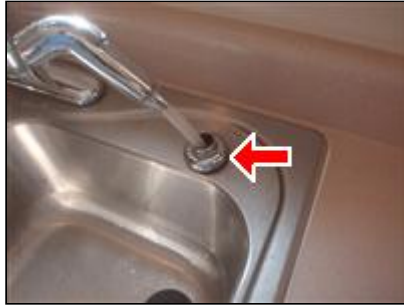
Item 3

- ♦
  1. The door of the microwave is broken and needs to be replaced if possible. The microwave did work but it may or may not be possible to replace only the door.
  2. The surface light for the microwave will not work; repair/replace.
  3. Repair/replace the loose kitchen sink spray hose.

- ☒ 9.
  1. The door of the microwave is broken and needs to be replaced if possible. The microwave did work but it may or may not be possible to replace only the door.
  2. The surface light for the microwave will not work; repair/replace.
  3. Repair/replace the loose kitchen sink spray hose.
