**2758 Example Avenue  
St. Louis MO**

**Client(s): Example  
Inspection Date: 7/2/2018**

**Inspector: BPG Inspector #IL 450.000775 (IL), (MO)**

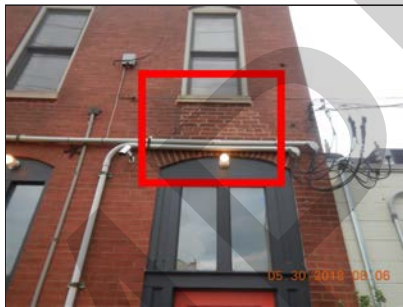
- ◆ The fire escape attached to west side of building was not walked and the condition of its attachment points are unknown. Have each attachment point closely inspected to be sure conditions are safe. The visible areas appeared acceptable.
- ◆ Small area over SW entry needs minor tuckpointing.

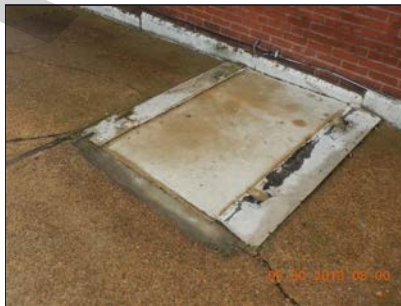
- ☒ ◆ City sidewalk along west side of building is very cracked and deteriorated. Replacement of the concrete seems like the best solution. Inquire if you or the city is responsible. Not estimated due to unknowns.

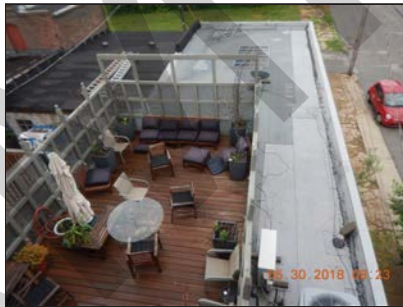
overview

- ✘ ◆ The roofing over the mid section of the building is deteriorated, about 15 + years old, losing aggregate, has various gaps, is ponding water along the gutter area, no termination bars at edges and rear gutter area and has been sealed with tar at seams. We recommend replacement of this roof section at this time. If not replaced now, the roof possibly has 1 - 2 years of service remaining with possibility of leaks. This section is about 790 square feet. ~\$3000 - \$6000 to replace.

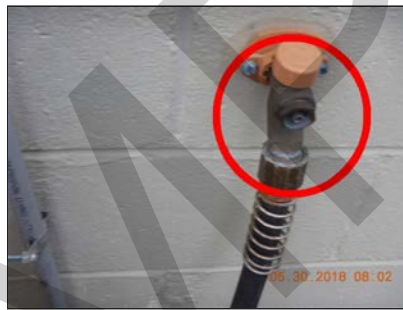
- ◆ The handle is missing from the west side hose faucet and faucet was not tested.

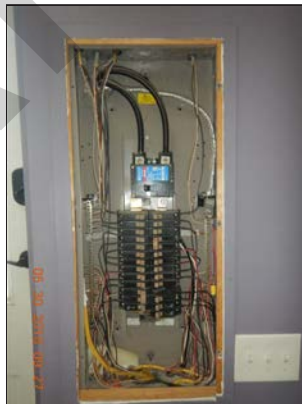
- ☒ ◆ The electric panel for the rear apartment is in a closet. There should be three feet of clear space in front of electric panels and panels should not be located in closets. Remove the storage from in front of the panel for safety reasons.

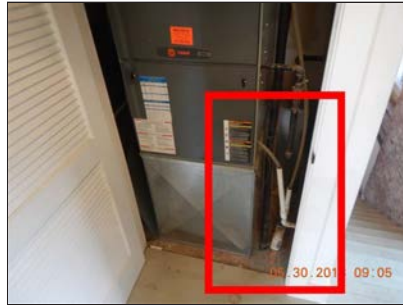
- ✗ ◆ At the basement furnace the condensate pump is leaking out water. Have it repair/replaced at this time. ~\$250 - \$500.

- 15. At the basement furnace the condensate pump is leaking out water. Have it repair/replaced at this time. ~\$250 - \$500.

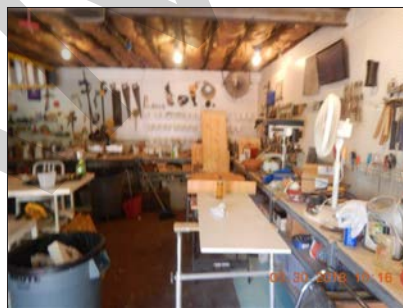
- ◆ The wall between the garage and the apartment is covered in drywall. Be sure to maintain this wall with no holes etc. for fire safety reasons.
- ◆ The garage door openers are connected to the light switch. If lights are off the overhead door openers wont work. Have electrician provide dedicated power to the overhead doors. ~\$300 - \$600

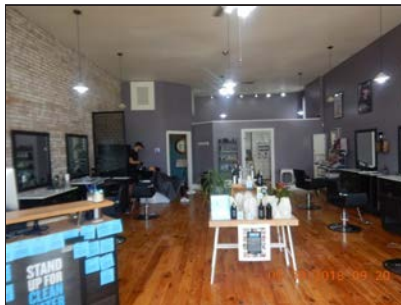
- ⬆️ ♦️ **Please be advised that a mold inspection is beyond the scope of this standard building inspection as defined by ASTM E2018-15 . This inspection did not include an inspection for mold.**
- ♦️ Camera system was not inspected or tested.
- ⊗ ♦️ To meet safety standards, install handrailing at all the steps, e.g. at all center area stairs to 2nd floor and basement.

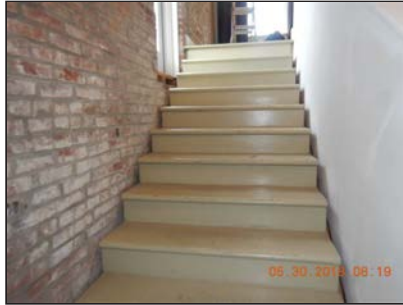
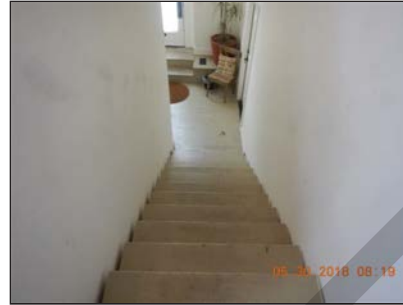
- ☒ ◆ Enclose the side of the steps to 3rd floor so there are no gaps greater than four inches.
